RAIL TRANSPORTATION SAFETY INVESTIGATION REPORT R18W0007

MAIN-TRACK TRAIN DERAILMENT

Canadian National Railway Company

Mile 166.33, Redditt Subdivision

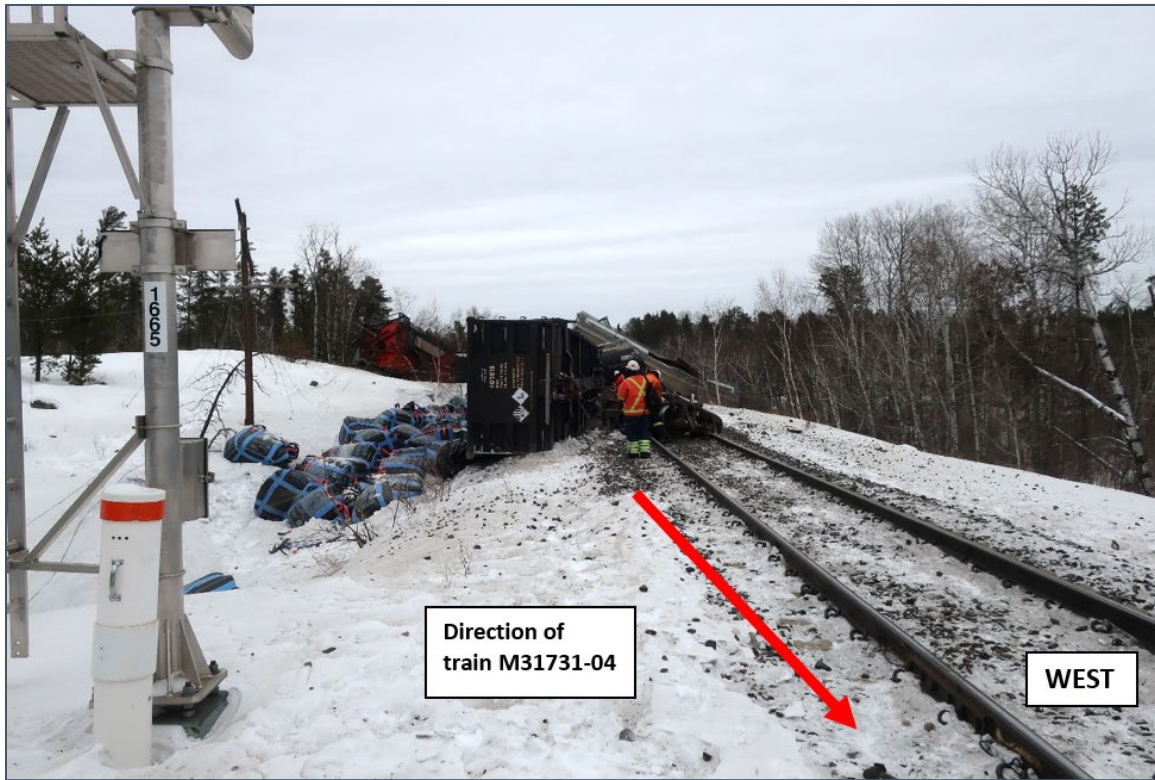
The first 2 derailed cars were the 38th and 39th cars from the head-end, which had overturned to the north side of the track. Both were open-top gondola cars, loaded with bags of nickel sulphides that spilled onto the railway right-of-way (Figure 2). However, no product was released from the bags.

Figure 2. Nickel sulphide bags spilled from first derailed car (Source: TSB)

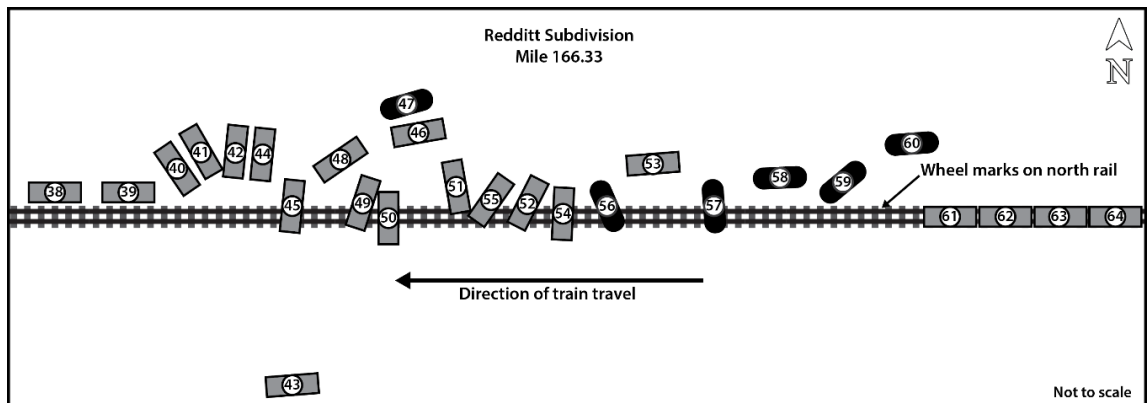
The following 21 cars had derailed and come to rest either to the north of, or along, the track in various positions over the following 650 feet (Figure 3).

Figure 3. Site diagram showing location of derailed cars after the accident (Source: TSB)

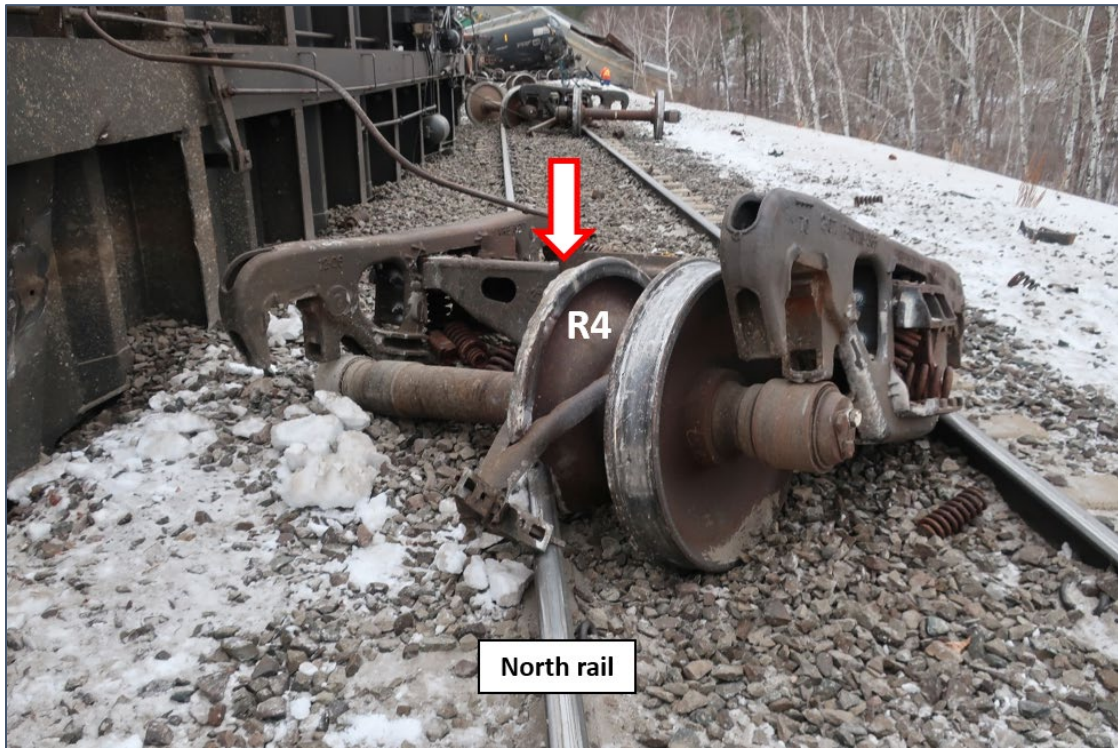
The 38th car (car ATW 400515), the first derailed car, had come to rest at Mile 166.48. The car's trucks were on the track next to the ends of the car. The R4 wheel from the leading A-end truck of the car had broken, come off its axle wheel seat, and moved inboard along the axle body before coming to rest against the L4 (mate) wheel (Figure 4).

Figure 4. The R4 wheel of car ATW 400515 (indicated by the arrow) had been displaced from the axle wheel seat and had moved inboard adjacent to the L4 wheel, coming to rest on the north rail. (Source: TSB)

The R4 wheel rim had fractured circumferentially. The outer portion of the rim was not recovered. The tread and flange were damaged, and a section of the wheel tread and plate had broken away. Two additional pieces of the wheel were found between the rails about 100 feet and 190 feet east of the truck, respectively. A 6-inch portion of the wheel rim/tread was never located. The wheel and recovered wheel pieces were forwarded to the Transportation Safety Board of Canada (TSB) for detailed examination.

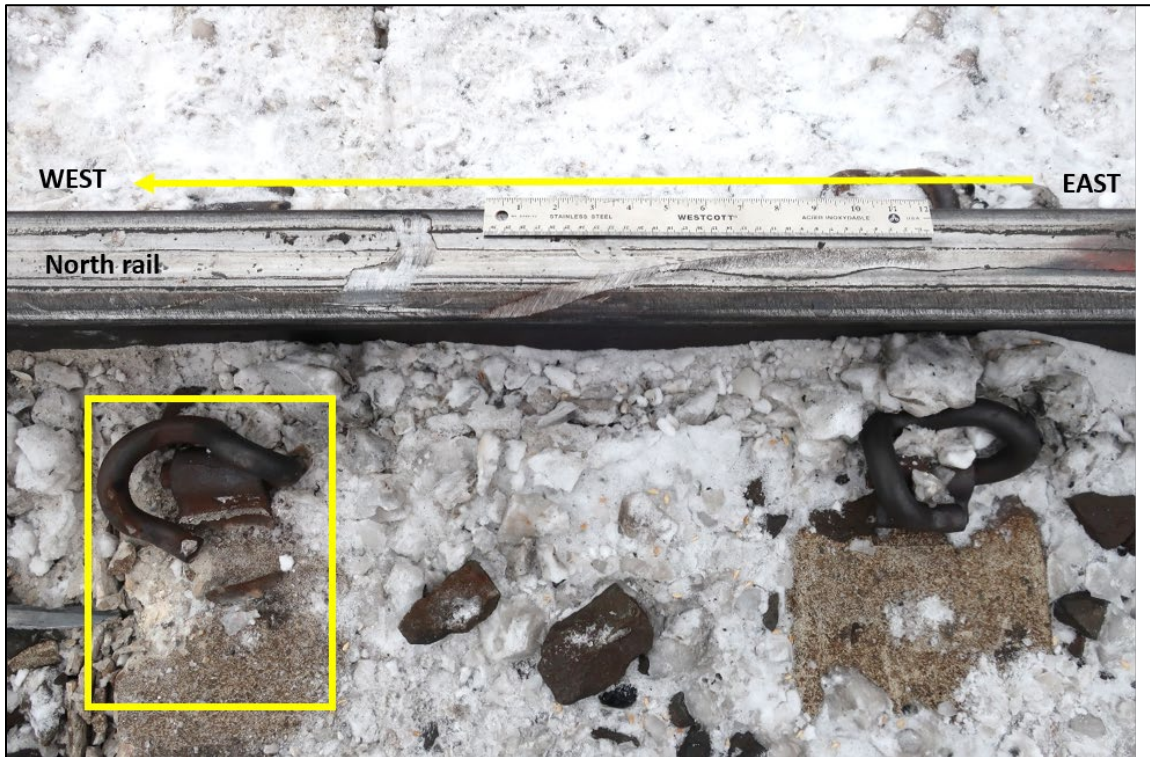
At the east end of the derailment site, a wheel mark was observed on the running surface of the north rail at Mile 166.33, starting in the middle of the running surface and extending westward for about 9 inches toward the gauge side of the rail. A small piece of wheel tread was observed between the rails adjacent to the wheel mark. Immediately west of the wheel mark, there was damage to the track fastener (gauge side) and to the concrete tie (Figure 5).

Figure 5. Wheel marks on the top of the north rail and the damaged gauge-side track fastener and tie (shown in the box) at Mile 166.33 (Source: TSB)

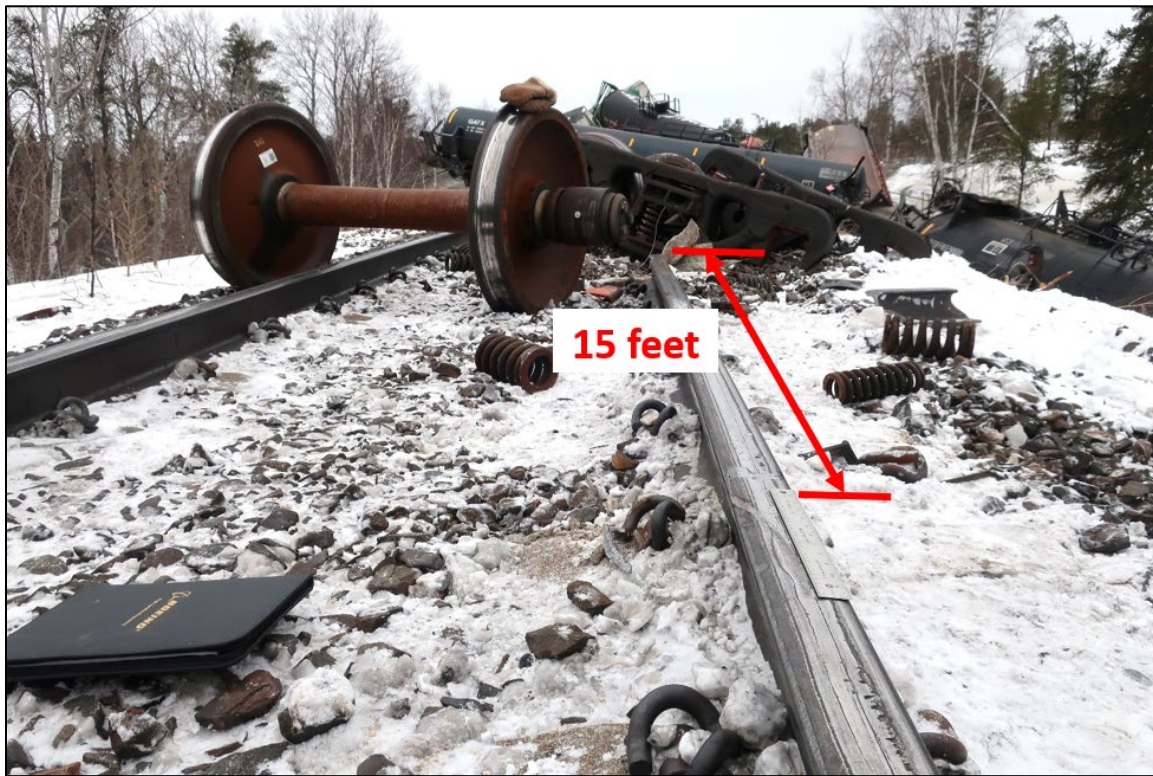
Three feet further west, the tie was damaged on the field side of the south rail, and, about 15 feet beyond the wheel mark, the north rail was broken (Figure 6).

Figure 6. Broken north rail 15 feet beyond the wheel mark on top of the rail (Source: TSB)

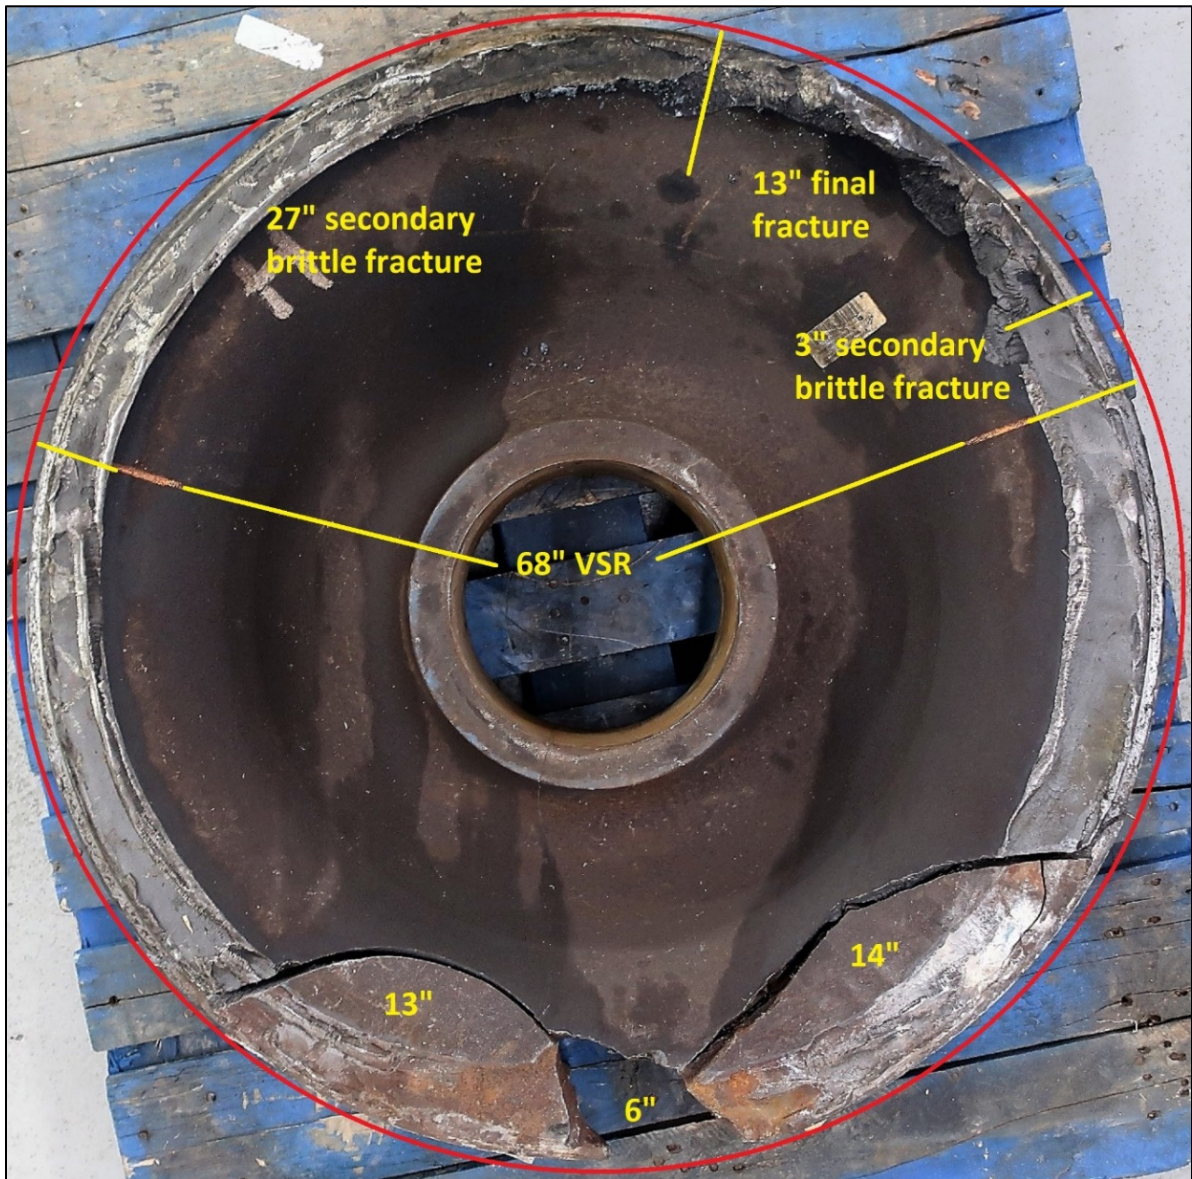
- The primary wheel failure was caused by a VSR.
- The unsupported wheel rim/tread overhang had failed in brittle and catastrophic modes around the wheel’s entire circumference (111 inches). The severed rim measured 2 inches at its widest point. None of the wheel rim’s separated, unsupported overhang was recovered.
- The VSR displayed vertically oriented, progressive, brittle growth rings on the rim face fracture surface, which propagated circumferentially in opposite directions from an initial fracture origin, reaching an overall length of 68 inches (Figure 7).

Figure 7. Fracture surfaces and failure zones of the R4 wheel on car ATW 400515 (Source: TSB)

The R4 wheel rim fracture surfaces exhibited mechanical damage, due to contact with the north rail, and several zones of progressive failure throughout its circumference.

- The primary failures involved 3 adjoining pieces of the wheel rim's unsupported overhang and tread, measuring 14 inches, 6 inches, and 13 inches. Oxidation was present on the 13-inch and 14-inch sections, indicating that some portion of the fractures had existed for some time before the final failure.
- Fractures extended into the wheel plate and resulted in the separation of the 3 pieces. The 6-inch wheel rim/tread piece was not recovered. Retracing the patterns observed on the fracture surface indicated that the VSR likely originated in the missing 6-inch tread piece.
- Brittle fractures, characterized by the presence of v-shaped chevron patterns, continued from the extremities of the VSR; these measured 3 inches and 27 inches, circumferentially.
