RAIL TRANSPORTATION SAFETY INVESTIGATION REPORT R18W0007

MAIN-TRACK TRAIN DERAILMENT

Canadian National Railway Company

Mile 166.33, Redditt Subdivision

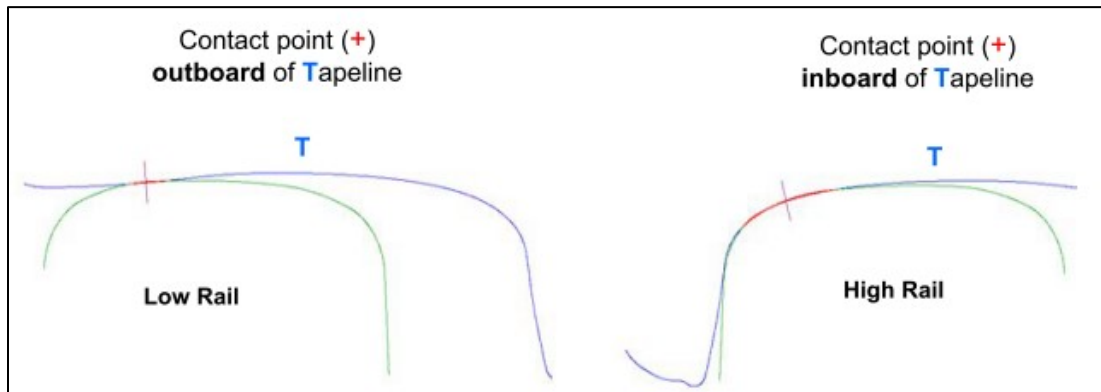
which permits the field side of the wheel tread to be scanned as it traverses the low rail of the curve (Figure 8).

Figure 8. Contact points for wheel impact load detector installation in curves (Source: A. Poudel and M. Witte, "Effectiveness of cracked rim detectors to identify broken wheels," 23rd Annual TTCI Research Review, Colorado Springs, CO [March 2018].)

The recorded impact loads from the tangent WILD and the WILD installed on the curve are compared. Significant differences between the recorded impact loads typically identify wheels with damage on or near the edge of the tread on the field side of the wheel. One challenge for installing this system is to find curves that have relatively high train speeds and curvatures greater than 7°.
